## **From the quarry to the monument: integrated study of São João de Calvos Church (Guimarães, Portugal)**

De la cantera al monumento: estudio integrado de la iglesia de  
São João de Calvos (Guimarães, Portugal)

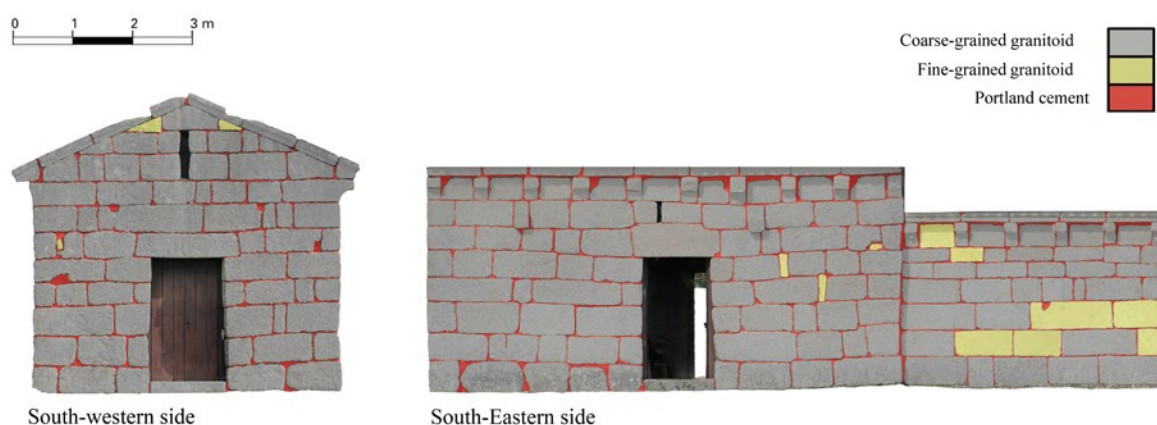
As shown in Fig. 9, the church, in its current state, is characterised by three main construction materials: blocks of two different types of granitoid, which will be discussed later, bonded together with Portland cement. The latter was poured and spread during the restoration work carried out by the local *Direcção-Geral dos Edifícios e Monumentos Nacionais* after 1970 (Phase IIIc). The cement fillings were most likely applied due to the deterioration of the original bedding mortar, which in monuments from that period was often air-lime type and poorly resistant to weathering processes. It is believed that the mortar experienced significant washout and disaggregation, which exposed the edges of the ashlar. This issue is quite common and has also been observed in other buildings of the same age (Sitzia, 2024).

Figure 9. Results of the ashlar's geological mapping across the south-western and south-eastern side of the church. Digital processing by authors.

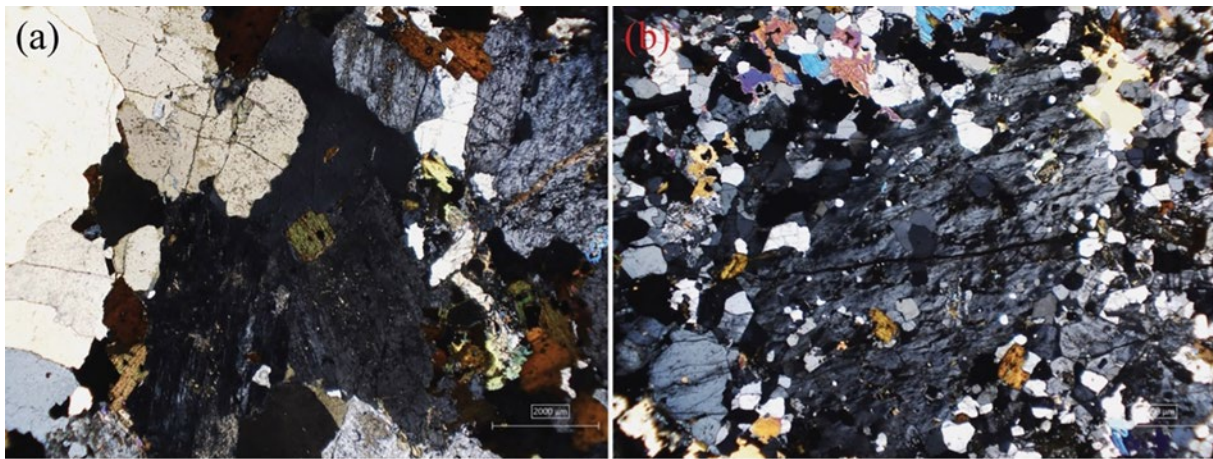
The analysis of the two granitoids in thin section is shown in Fig. 10a and 10b, while Table 1 presents some basic physical properties of the fresh stone. According to the geological map provided by the *Laboratório Nacional de Energia e Geologia*, the coarse-grained granitoid used in the church is described as *Guimarães-Santo Tirso* biotitic granitoid and coarse-grained porphyritic monzogranites, belonging to the late-tectonic Hercynian lithologies.

Figure 10. Thin section of coarse-grained granitoid (a) and fine-grained granitoid (b). Both photographs were taken by crossed nicols. Photos from authors.

The more advanced weathering of the coarse-grained granitoid is primarily controlled by its textural features, and only secondarily by the physical properties reported in Table 1. Although helium open porosity (one of the parameters influencing decay, Lisci *et al.*, 2023) is lower than in the fine-grained granitoid ( $3.36 \pm 0.49 \%$  vs  $10.72 \pm 1.79 \%$ ), and water retention properties ( $0.99 \pm 0.10 \%$  vs  $3.20 \pm 0.45 \%$ ) are more favourable, the large crystal size and lower intergranular cohesion promote grain detachment and sanding, leading to greater susceptibility to alteration. To assess the current decay state of both stones, a comprehensive ultrasonic pulse velocity survey was conducted across the four main elevations. An example of the survey conducted on the elevations south-western and south-eastern is illustrated in Fig. 11.

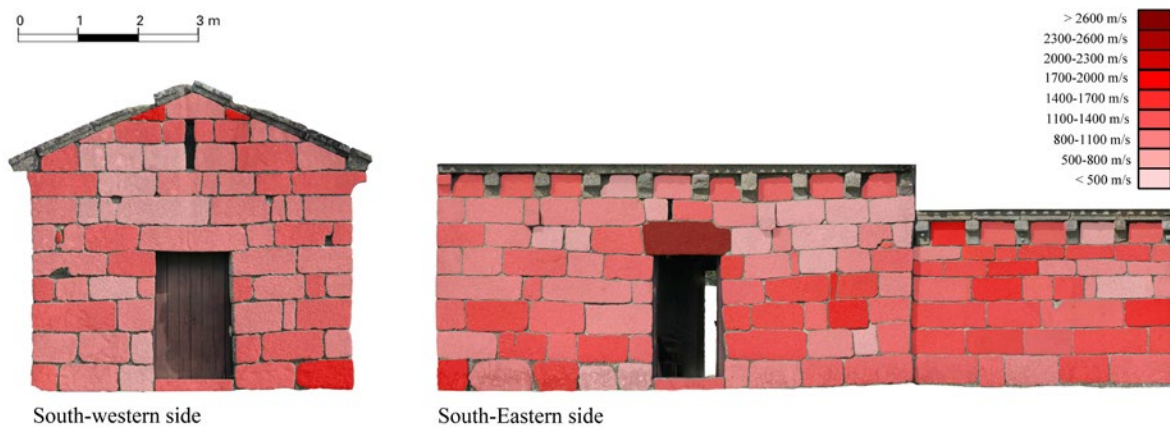
Figure 11. Results of the ultrasonic survey across the south-western and south-eastern side of the church. Digital processing by authors.

This façade presents the lowest average Velocity Ratio Index (0.54), with only 2.9% of ashlar classified as “Good or very good” and a notable 20.6% rated as “Poor or very poor.” The remaining 76.5% fall within the “Fair” category, indicating generalized but not critical degradation. These results are consistent with visual assessments that revealed surface scaling, advanced granular disintegration and biological crusts.

This orientation is particularly vulnerable due to a combination of factors: prevailing westerly winds, higher exposure to driving rain, and limited morning sunlight which delays drying cycles (Lisci et al., 2022). Moreover, the structural damage identified in the lintel beneath the bell gable, previously documented via micro-photogrammetry, reinforces the need for immediate stabilization and continuous monitoring. The material in this zone is not only physically stressed by structural loading but also suffers from thermal gradients and water ingress.

Despite its southern orientation, this façade shows only a moderate state of conservation, with a mean Velocity Ratio Index of 0.57 and 16.8% of ashlar classified as “Poor or very poor.” The majority (79.4%) are in “Fair” condition, while only 3.7% fall into the “Good or very good” category.

Given its relatively favourable exposure, these results suggest the influence of localized pathologies rather than environmental factors alone. Potential contributors include thermal fatigue, particularly in stones with anisotropic thermal expansion, and architectural detailing that provides inadequate protection for joints or horizontal surfaces, thereby promoting water retention and salt crystallization. Although this façade does not exhibit severe generalized degradation, specific isolated zones would benefit from water-repellent treatments (or hydrophobic protection) and surface consolidation.

- The south-western and north-western elevations represent the zones of highest vulnerability and should be prioritized in early-stage conservation campaigns.
- The proposed differential photogrammetric survey technique, aimed at tracking material volume loss over time, should be focused on the most affected elevations, particularly around structural discontinuities such as lintels and joints.
- Integration of these results into the monument's HBIM model supports not only condition assessment but also long-term monitoring, simulation of deterioration scenarios, and optimization of resource allocation.

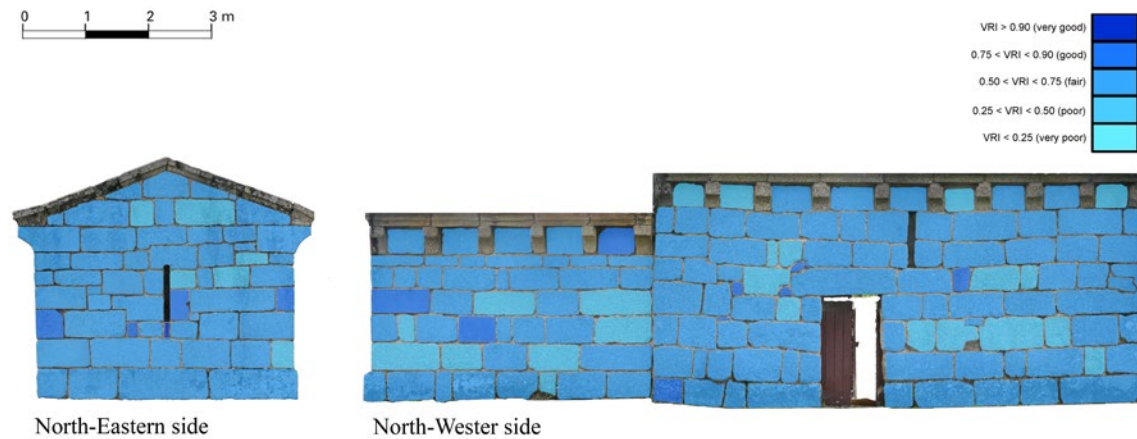
This degradation pattern reflects typical north-western exposure, characterised by limited solar radiation, persistent humidity, and extensive biocolonization. Additionally, evidence of historical interventions and repointing with Portland cement (identified in previous stratigraphic assessments) may have induced differential stress concentrations and microcracking, exacerbating decay in specific zones. Consequently, this façade should be considered a priority for non-invasive biocidal cleaning, water run-off improvement, and microstructural consolidation of the most degraded ashlar.

Figure 12. Results of the QMB characterisation across the north-eastern and north-western side of the church. Digital processing by authors.

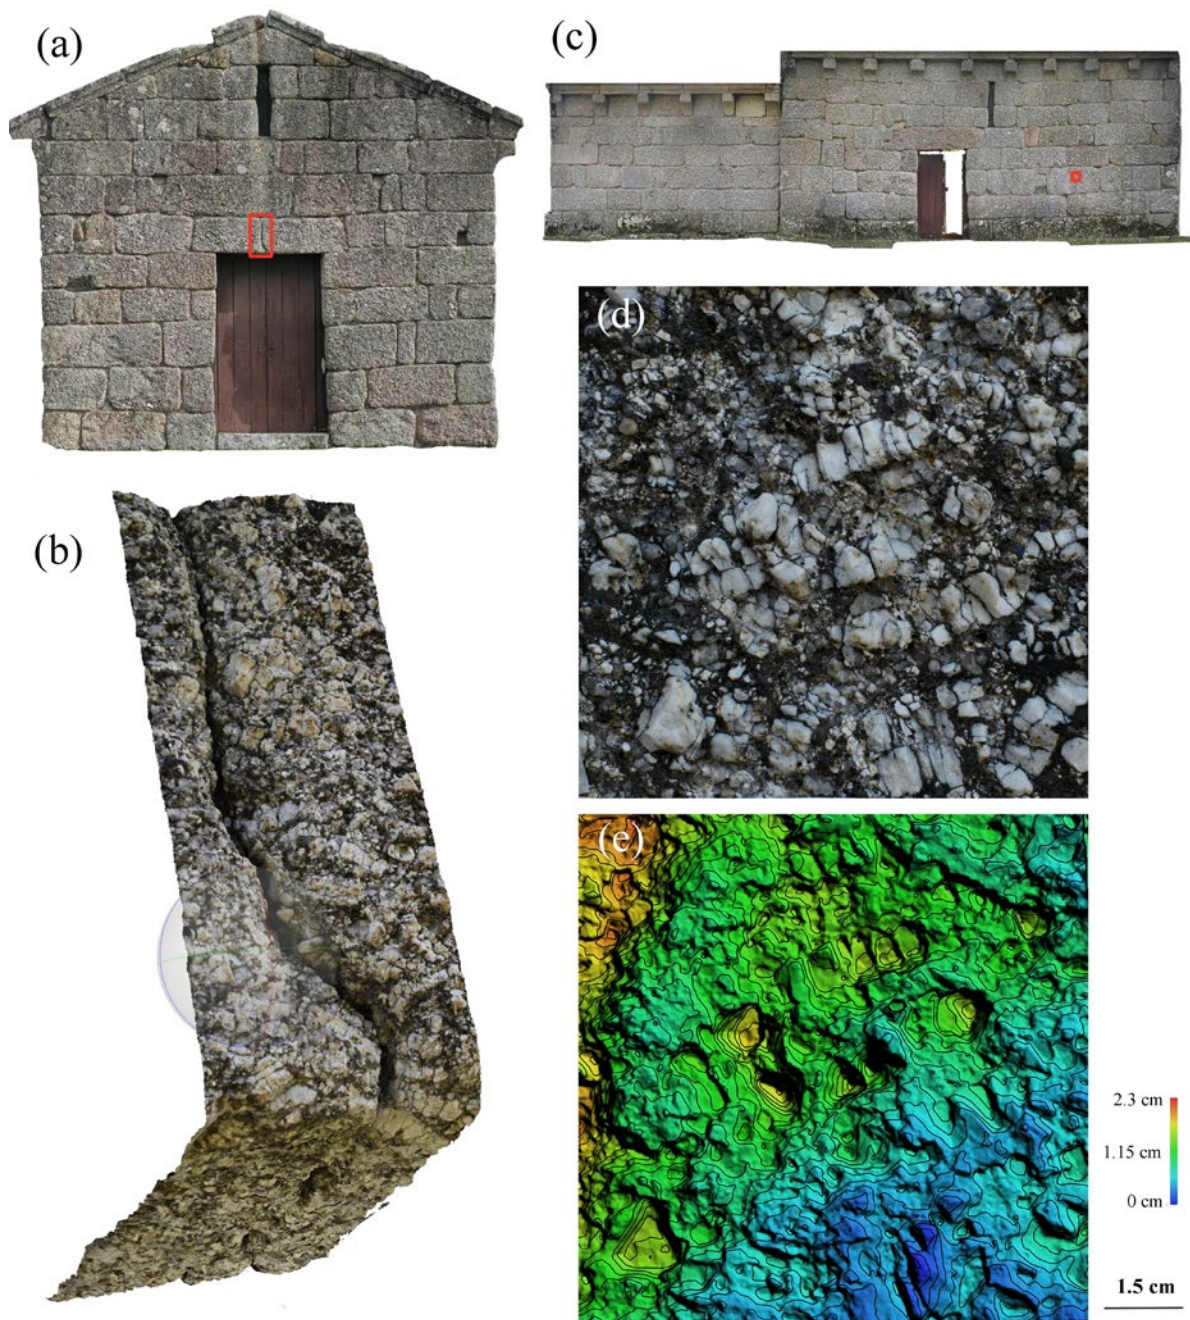
**A202** (SU027) corresponds to the abrasion tracks left by the friction of the rope used to ring the bell, between the cornice and the door lintel. This action caused alterations to the slit window located above the door, as well as a crack in the lintel.

An important aspect of the building's digitization involved the production of detailed micro-photogrammetric models over areas of approximately 100 cm<sup>2</sup>. This approach aimed to document the masonry to quantify material loss. The same method was used for monitoring the opening and evolution of fractures detected in the monument, specifically the crack in the lintel of the south-western façade caused by the structural load of the bell tower (Fig. 13a, b).

Figure 13. Micro-photogrammetry survey: (a, b) lesion affecting the architrave on the south-western façade, (c) scanned area by micro-photogrammetry on the north-western side of the church, (d) snapshot of the scanned area, (e) model of the  $100 \text{ cm}^2$  scanned area, contour line spacing =  $0.001 \text{ m}$ . Digital processing by authors.
