## Exploration and Digitalization of Historical Heritage: Tur Abdin Region and Mor Loozor Monastery

İzzettin Kutlu

Mardin Artuklu University, Turquía

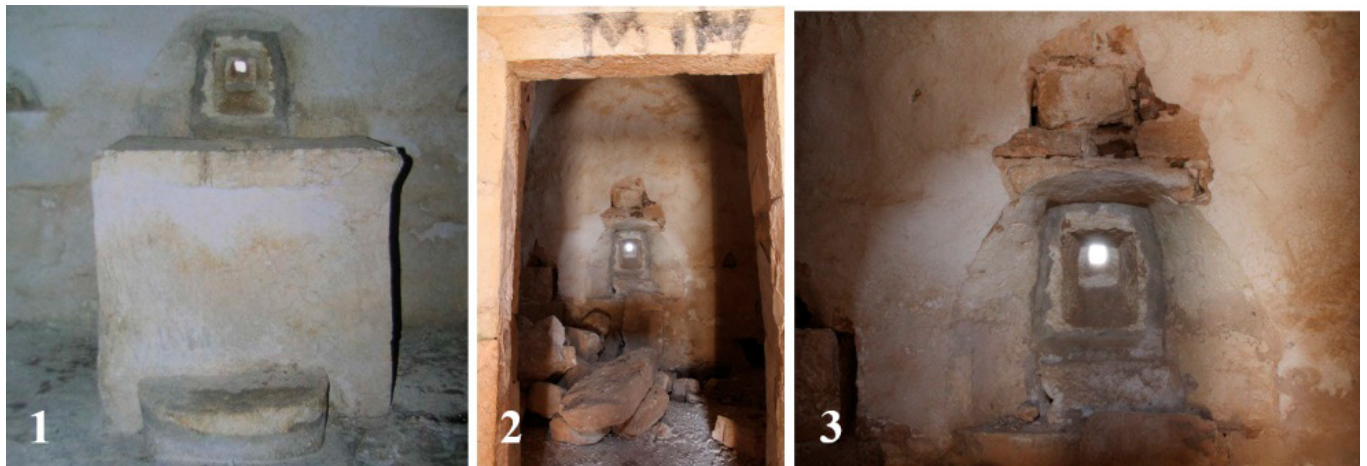
Figure 9. Mor Loozor Monastery. 1: Old view of the sanctuary (Hollerwerger 1999). 2 and 3: 2024 view indicating its destruction in the last 15 years (photo by the author).

Bell and Mundell Mango (1982). Inside the church are arched niches and horseshoe arches on both sides of the entrance door on the west wall. The church interior was divided into two main spaces- the nave and the sanctuary.<sup>8</sup> The sanctuary, located in the eastern direction, was the sacred area reserved for religious rituals and ceremonies. In the upper levels of the church, there were small windows for ventilation and niche-shaped openings, though these did not directly connect to the exterior. The height of the sanctuary space exceeded that of the other areas within the monastery complex, likely indicating its specialized liturgical function. Three cistern holes were found in various sections of the church. Currently, these cistern features are partially filled with rubble and soil. Access to the sanctuary from the nave was through a pointed arched portal, typical of Syriac church architecture. The sanctuary was only accessible to the clergy and high-ranking religious personnel in accordance with liturgical conventions. Hollerwerger (1999) documented the presence of an element referred to as a “throne” or “table of life” situated in front of the cut stone window on the east wall of the naos. However, this area is now obscured by piles of rubble and soil (Fig. 9).

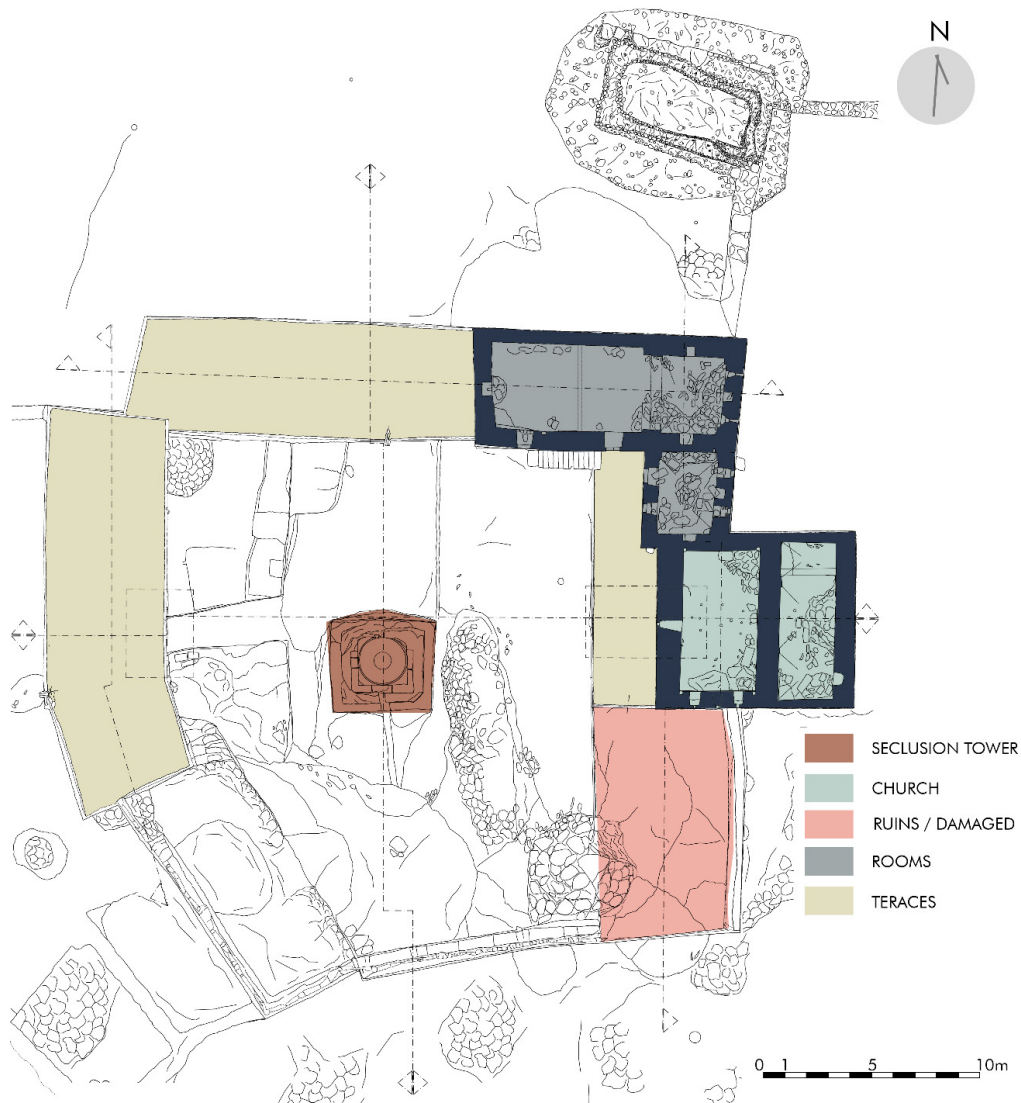
Figure 10. Mor Loozor Monastery first floor spatial plan features (adapted from Şanlıurfa Cultural Heritage Conservation Regional Board).

Stone stairs can access the second floor on the northeast side of the courtyard. On the second floor, there are open spaces in the form of a flat terrace roof and two rooms (Fig. 10). These rooms on the upper floor appear to have been originally used as dormitories. The rectangular room in the north, extending east-west, is accessed through a door with cut stones. Part of the upper cover of this room was reconstructed in reinforced concrete. On the east side of the same room, a cross vault built of original rubble stone can be observed. It can be assumed that the wall between the cross-vaulted section and the section with the reinforced concrete roof was demolished over time. This assumption is supported by the presence of many piles of stones and soil in this area and the differentiation of the roof structure.

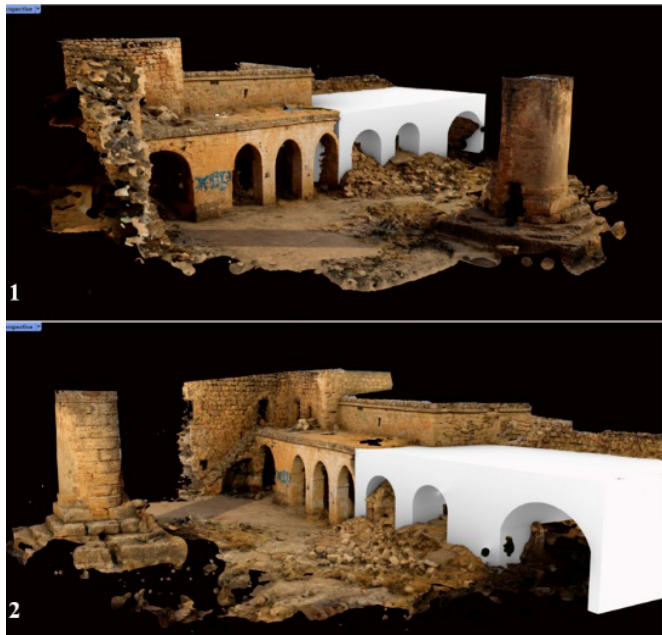
Figure 13. Processability of the photogrammetric model before restoration decisions using different 3D visualization programs (created by the author).

- In addition to obtaining two-dimensional drawings for the restoration works, interventions can be visualized and rendered in 3D on the model. Consequently, the balance of harmony between the building's original condition and the planned interventions can be assessed before implementation. The planned interventions, aligned with the building's requirements, can be organized within the three-dimensional model, allowing for an interactive process in a digital platform to reach a final decision that aligns with the building's character. The creation of a solid mass model of the demolished porticoes of the Mor Loozor Monastery serves as an illustrative model for this process (Fig. 13). The white area within the model was generated
