## **From the quarry to the monument: integrated study of São João de Calvos Church (Guimarães, Portugal)**

De la cantera al monumento: estudio integrado de la iglesia de  
São João de Calvos (Guimarães, Portugal)

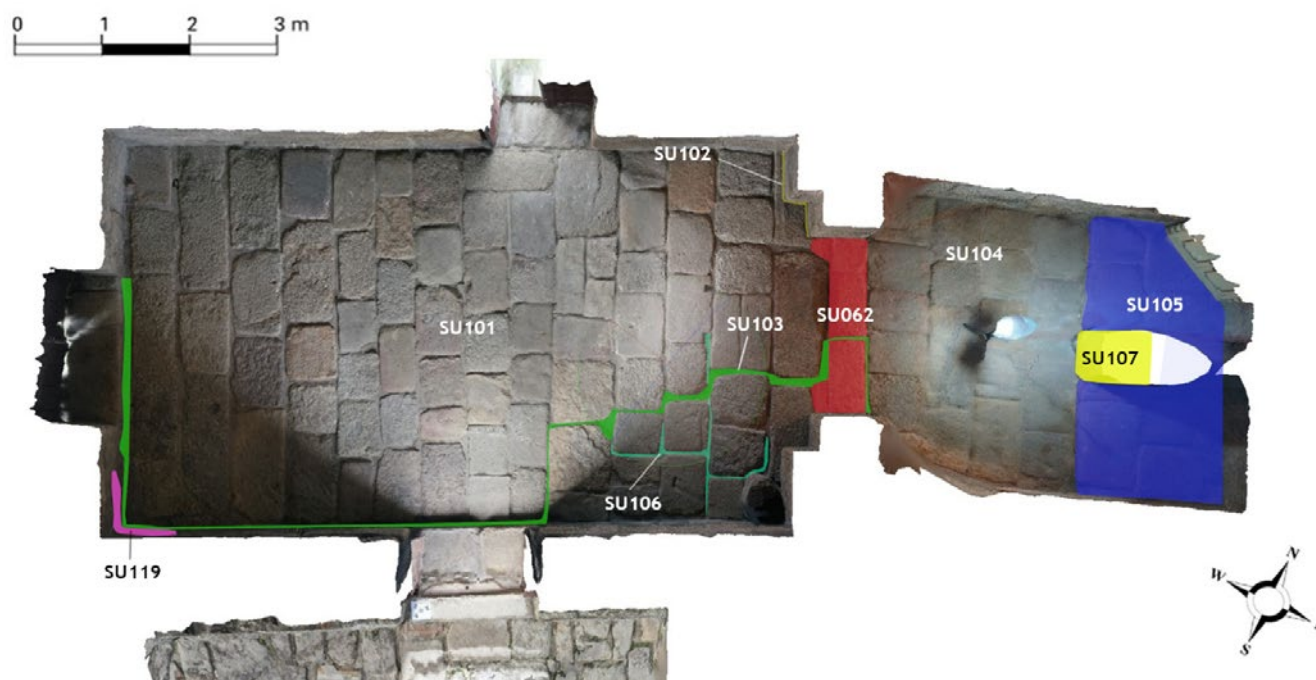
**A101** (SU104 and SU105) corresponds to the apse floor, composed of granitoid slabs (SU104) of varying size and shape, with a raised north-eastern section (SU105), sharing the characteristics of SU104.

Finally, **A102** (SU107) corresponds to the base of the original altar, consisting of a reused *ara* with a space for a lipsanoteca (reliquary), SU107, an element commonly found in medieval altars where materials from earlier periods were reused.

Figure 4. View from above of the church floor with relative indications of the SU.  
Digital processing by authors.

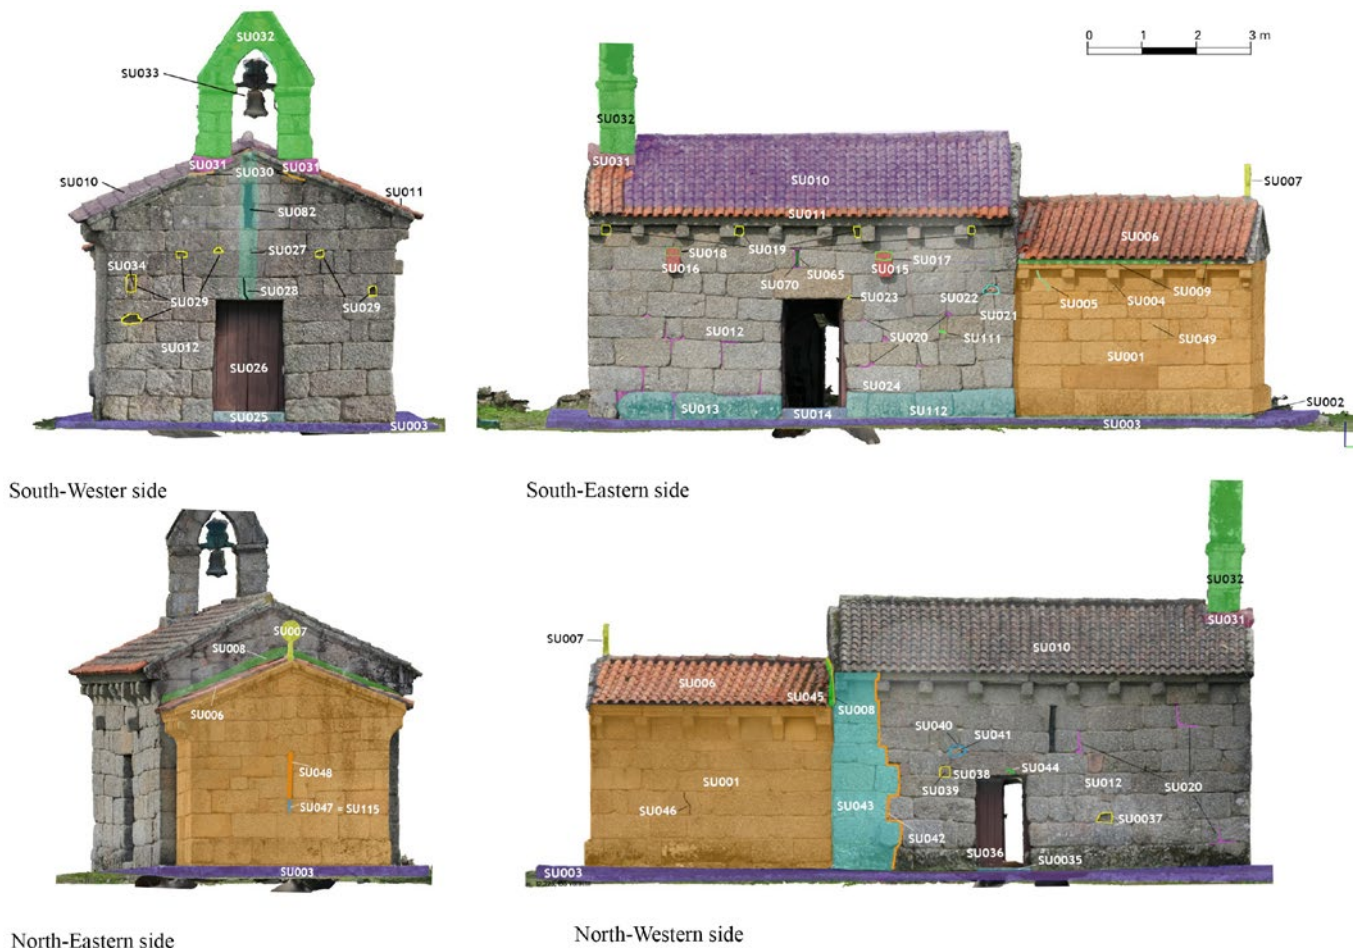
Figure 5. View from outside the church of the various walls with relative indications of the SU.  
Digital processing by authors.

**A103** (SU012, 013, 042, and 112) corresponds to the construction of the nave. Among the identified elements is a base course (SU013 and 112) supporting the nave wall (SU012), visible on the exterior south-eastern elevation and, in the case of SU112, also on the interior. It is composed of granitoid ashlar of greater height than those of wall SU012, projecting from the wall and only roughly dressed, thus resembling a plinth. On the exterior, it can be observed that there may have been another course below this one. The nave also has a rectangular plan and is built in granitoid ashlar masonry; however, it features courses of irregular height, many of them slightly sinuous rather than fully horizontal, and includes some headers and wedges. The ashlar are not regular, and some appear to have been reused. The cavetto-type corbels in this phase are wider and rougher than those of the apse, and the cornice has a simple square-section moulding. The cut of the original nave (SU042) on the north-western elevation has also been included in this activity, where the courses differ in height from those of Phase Ia, indicating they belong to different phases.

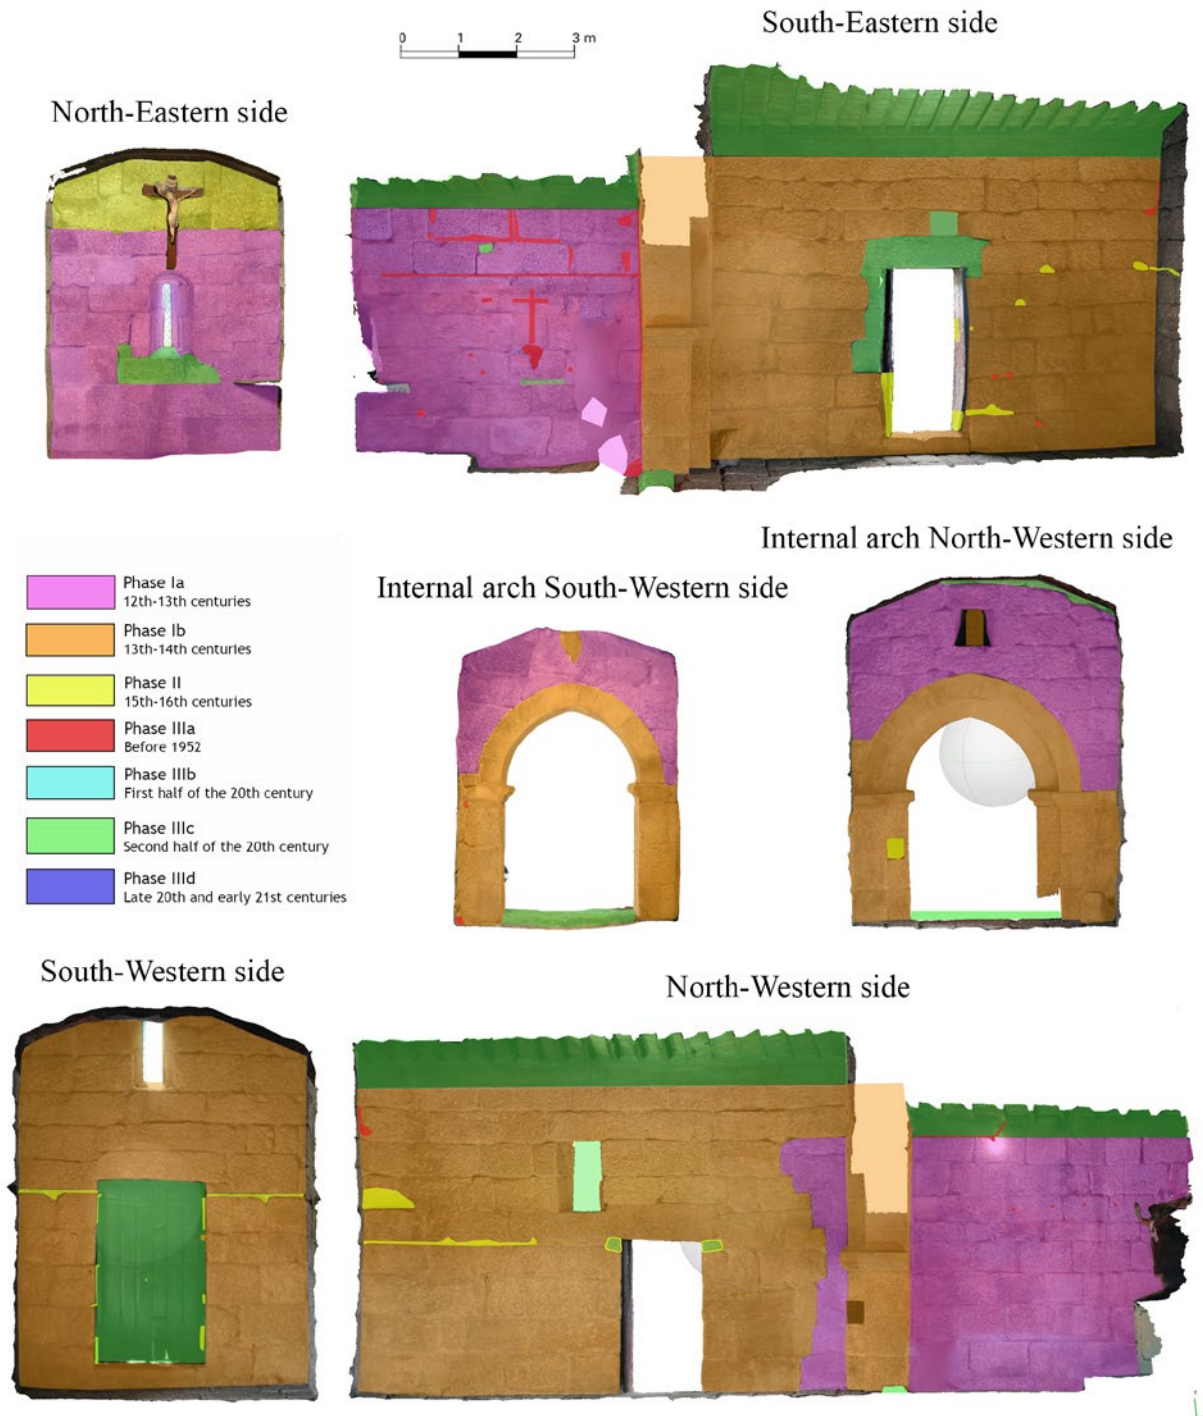
Figure 6. View from inside the church of the various walls with relative indications of the construction phases. Digital processing by authors.

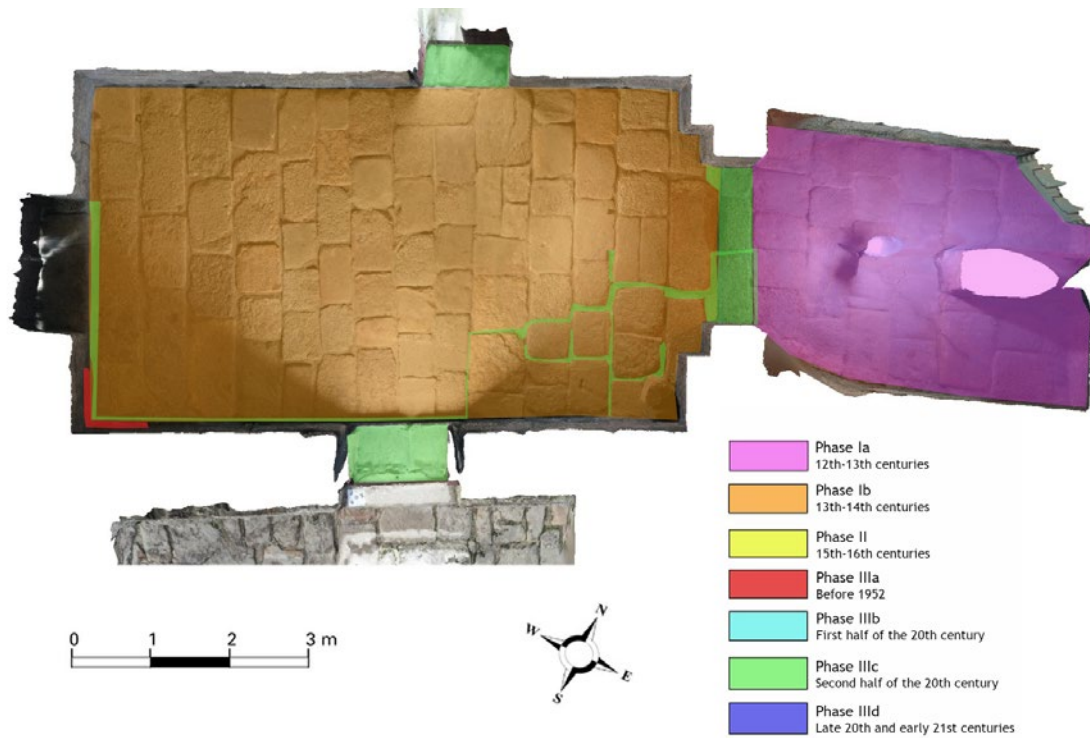
Figure 7. View from above of the church floor with relative indications of the construction phases. Digital processing by authors.

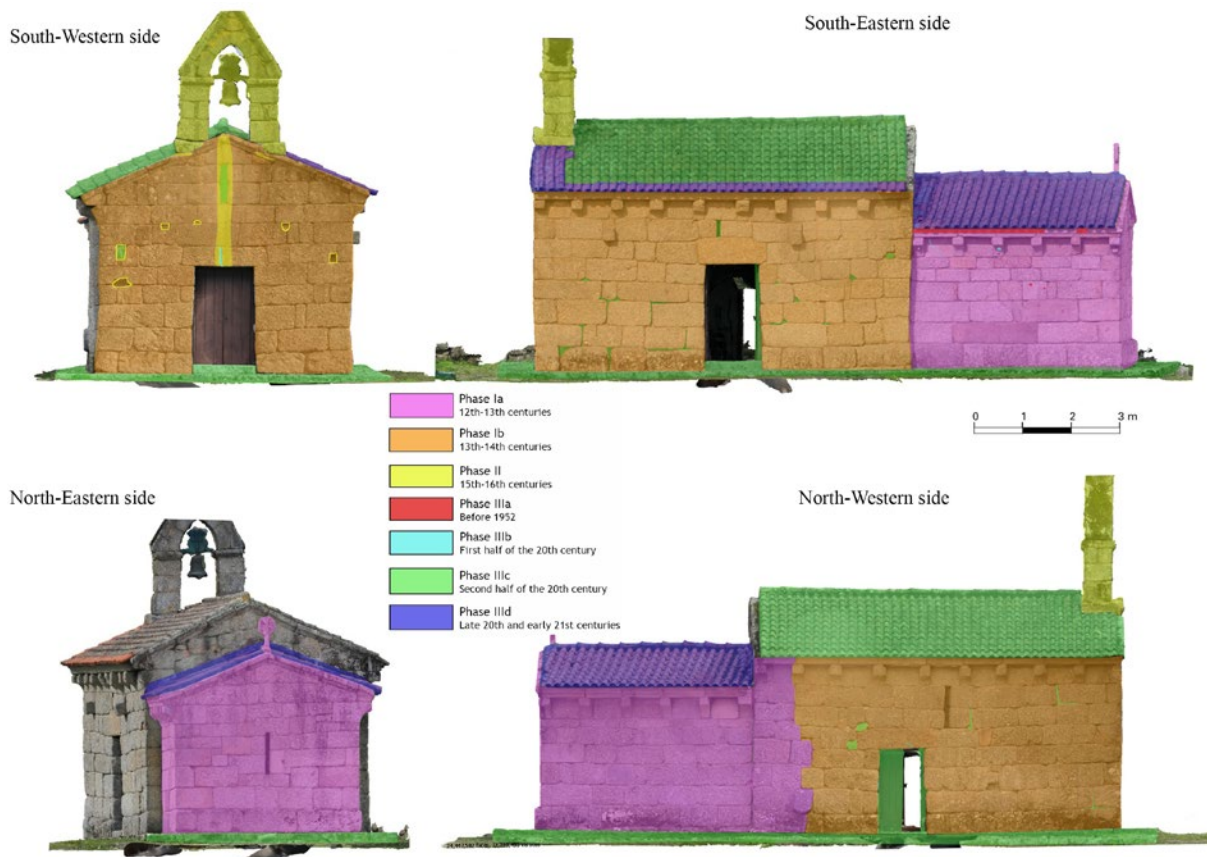
Figure 8. View from outside the church of the various walls with relative indications of the construction phases. Digital processing by authors.

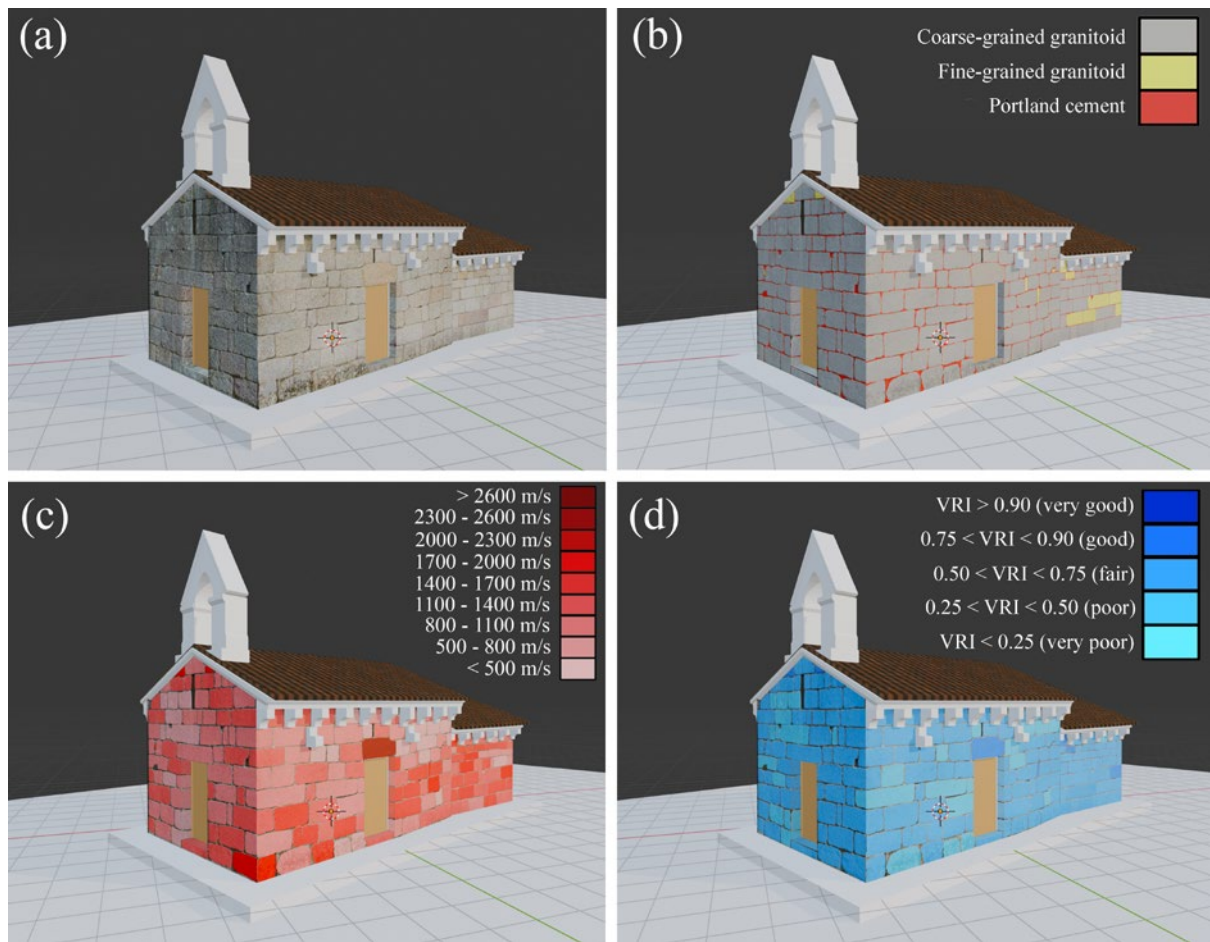
The dense point cloud generated from photogrammetric processing was exported in PLY format and imported into the modelling environment (VisualARQ/Rhino). This enabled direct modelling of the chapel geometry without requiring prior point cloud subsampling. Architectural elements were modelled interactively using a combination of parametric BIM objects, NURBS geometries, and custom parametric components implemented through Grasshopper, following an approach similar to that proposed by (Sun *et al.*, 2019). The resulting Level of Detail 200 HBIM model was exported to IFC, with semantic overlay generation and thematic mapping subsequently conducted in BonsaiBIM, as described in section 4.4 (Fig. 14).

Figure 14. Digitalisation of the monument in a Building Information Modelling environment and related thematic maps. RGB texture (a), lithological features (b), ultrasonic characterisation (c), Velocity Ratio Index and quality of building materials data based on ultrasonic survey (d). Digital processing by authors.

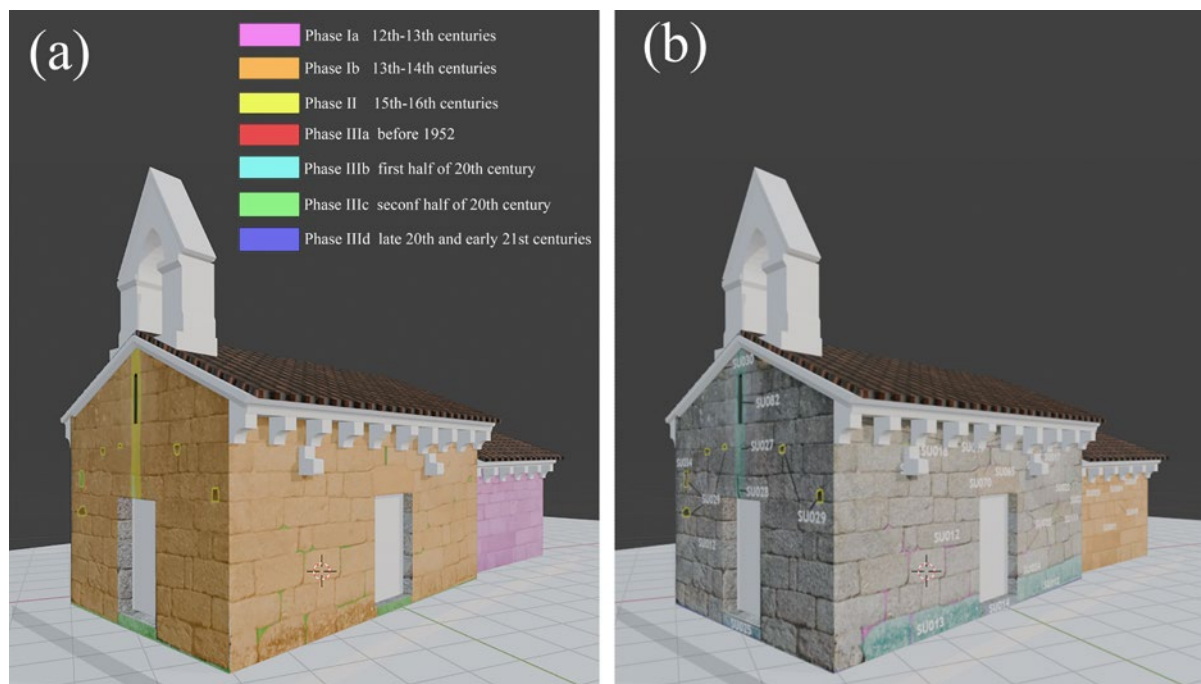
The proposed texture-based semantic overlay methodology enabled independent annotation of heterogeneous analytical datasets without requiring permanent geometric subdivision of the architectural model. After establishing UV coordinates for the proxy geometries and exporting the corresponding unwrapped texture maps, updates to thematic information could be performed directly through modification of the associated 2D raster maps. Adding new thematic layers was done successfully by generating additional proxy geometries and their corresponding texture maps without requiring remodelling of the primary HBIM elements. Fig. 15 shows the stratigraphic units and the construction phases of the south-western and south-eastern facades added at a later stage.

Figure 15. View of the south-western and south-eastern facades showing added thematic maps of construction phases (a) and stratigraphic units (b). Digital processing by authors.
